SALMON AND STEELHEAD HABITAT LIMITING FACTORS

**CHEHALIS BASIN AND NEARBY DRAINAGES
WATER RESOURCE INVENTORY AREAS 22 AND 23**

WASHINGTON STATE CONSERVATION COMMISSION FINAL REPORT

May, 2001

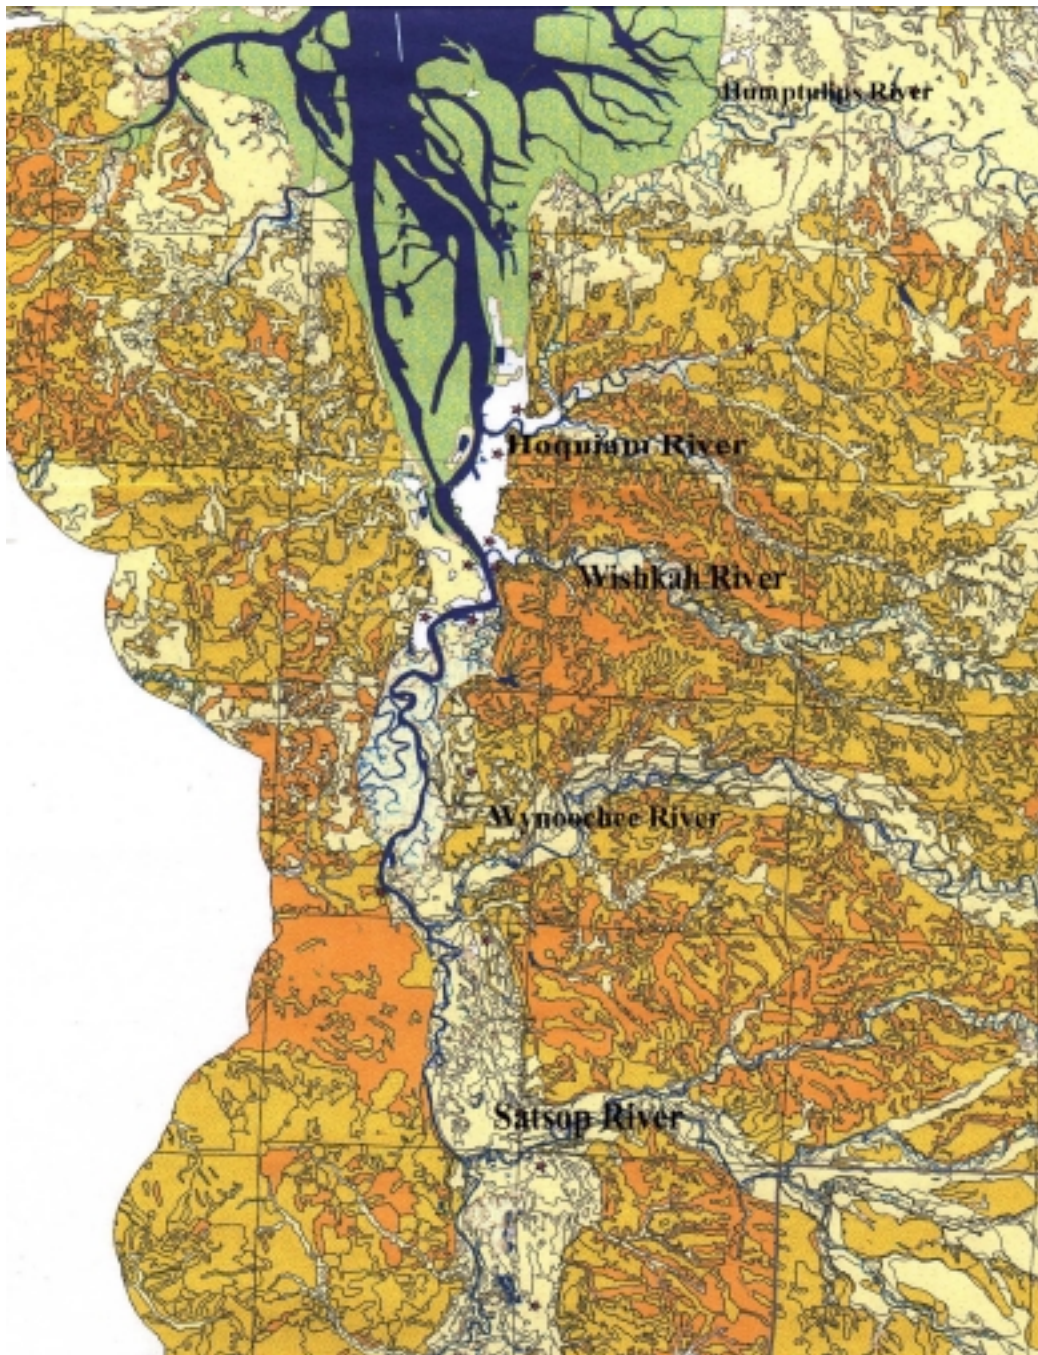
Figure 17. Erosion Potential in the Lower Chehalis Basin (DNR data 1992). The darker colors equal greater erosion potential.

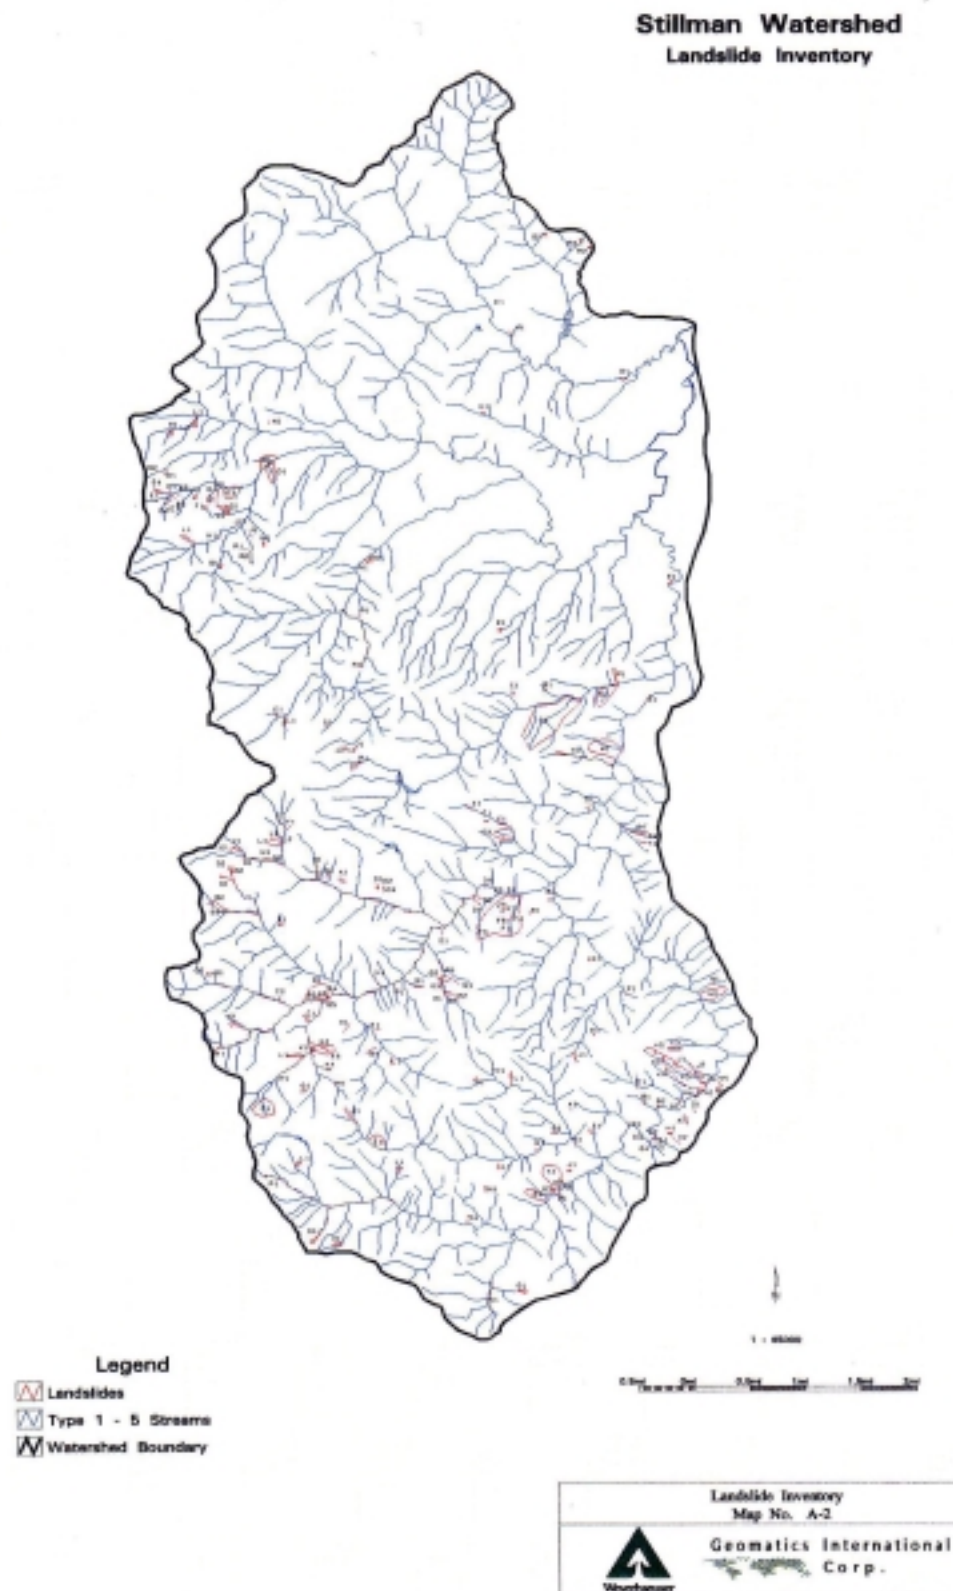
Figure 58. Landslides in the Stillman Creek Watershed (Laprade and Wilson 1994).

In most areas of the Stillman watershed, fine sediment (<0.85 mm) levels were generally low to moderate (2.5%-15.3%) (Hadley 1994). One sample in the upper Stillman contained 36% fines, an extremely high level that was probably due to the presence of a debris jam that once existed downstream of the sampling site. Overall sediment input from roads and hillslope erosion isn't large, but some road segments are problematic, such as roads in the lower Stillman, Lost Valley, and Halfway Creek watersheds. Most of the impacting roads are mainline roads close to streams, for example, the 4000 Road next to Slide Creek (Raines 1994). Overall road density is very high in the Stillman Creek WAU, at 4.5 miles of road/sq. mi. watershed (Lunetta et al. 1997).
